Department for Environment and Heritage Maintenance and Repair of Older Buildings in South Australia

Technical Note 3.1

Maintenance and Repair of Older Buildings in South Australia

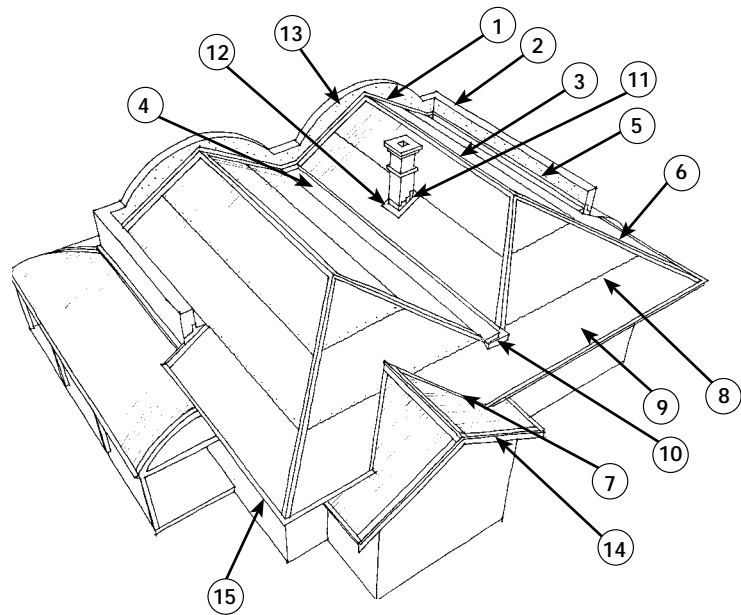
Typical Roof Anatomy

1. Parapet Flashing
2. Parapet Coping
3. Ridge Cap
4. Box Gutter
5. Flashing
6. Hip Capping
7. Valley Gutter
8. Sheet Laps
9. Corrugated sheet metal Roof Sheets
10. Rainwater Head
11. Stepped Chimney Flashing
12. Chimney Soaker Tray
13. Rendered Coping
14. Barge Capping
15. Eaves Gutter

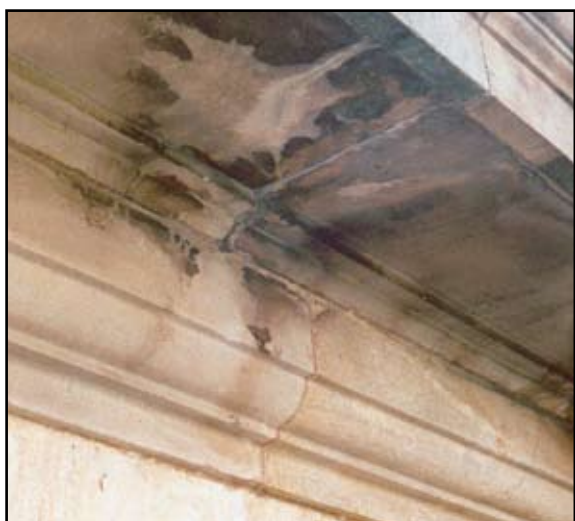
Mortar has been eroded from the joints in this stone cornice by the penetration of moisture through the top surface. Failure to repoint the joints has caused considerable damage to the stone either side of the joints. The damage is a form of salt attack due to air movement through the open joints in the presence of salts (from bird droppings for instance)

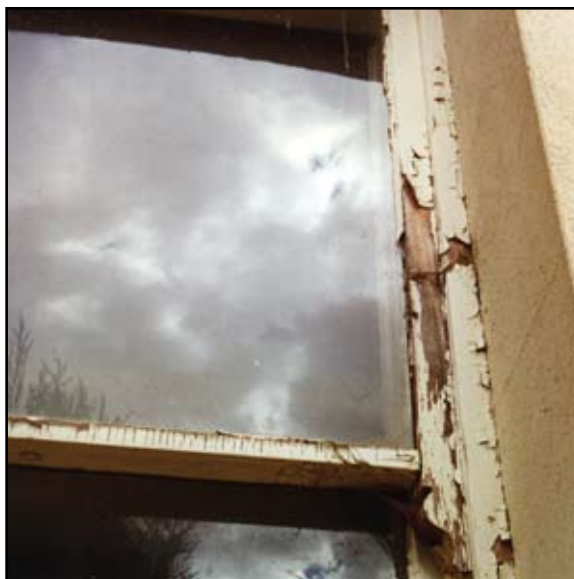
Peeling of paintwork is allowing rapid moisture damage to the window frame.

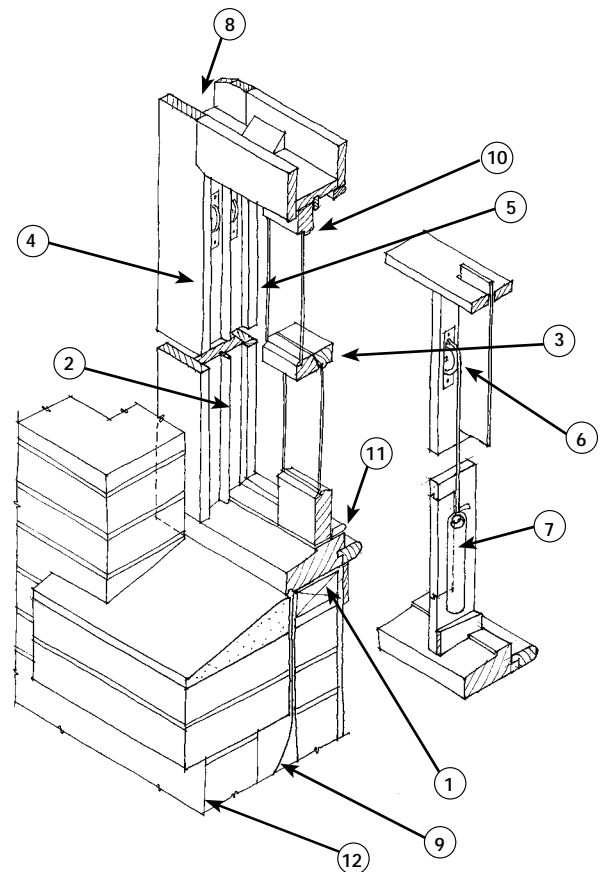
Typical timber double hung sash window - Portion of frame cutaway view

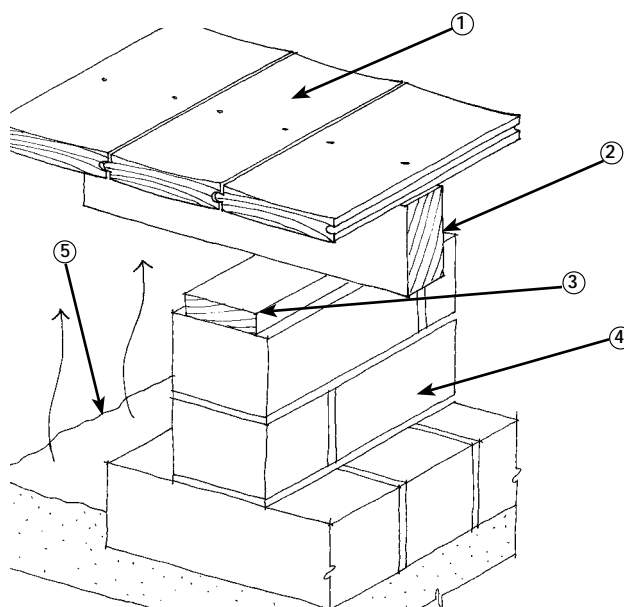
Cupped Floor Boards

1. Tongue and Grooved Boards
2. Hardwood Joist
3. Plate
4. Dwarf Wall
5. Soil Moisture Humidifies Sub-floor

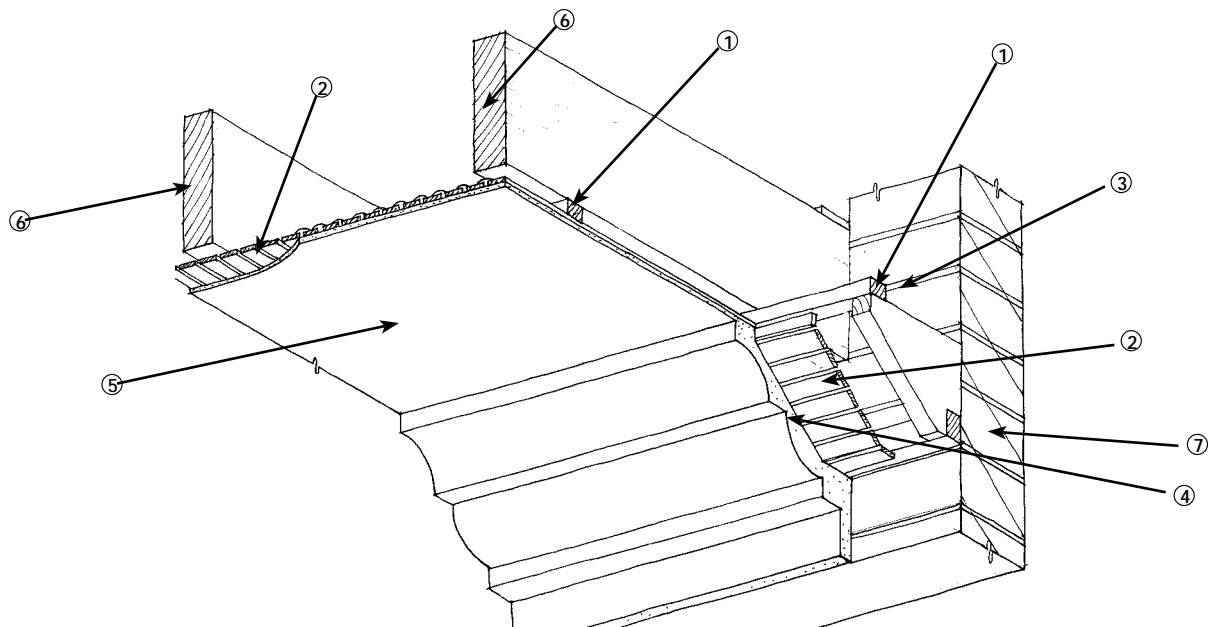
Typical Lath & Plaster Ceiling with Ornate Cornice

1. Hardwood Brackets
(Battens) 350c/c Max
2. Split Hardwood Laths

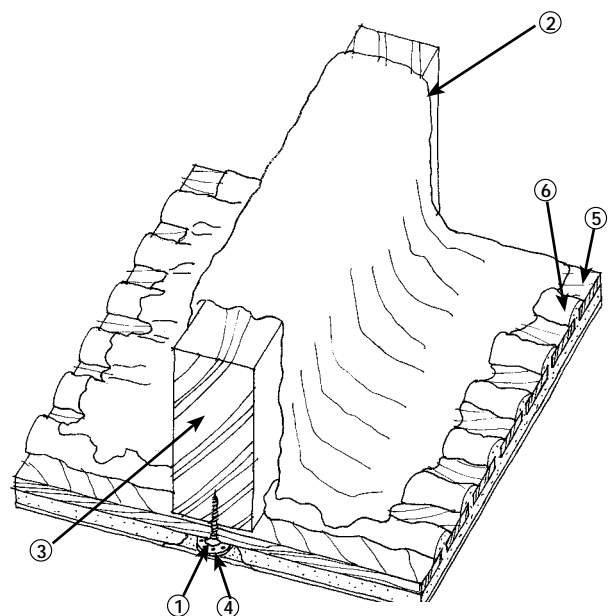
Ceiling Stabilisation screwed and looped method

1. Screw with washer fixing from beneath
2. Fibres set in plaster or acrylic resin
3. Ceiling joists – 350 max
4. Laths resecured to ceiling joists using brass screws with

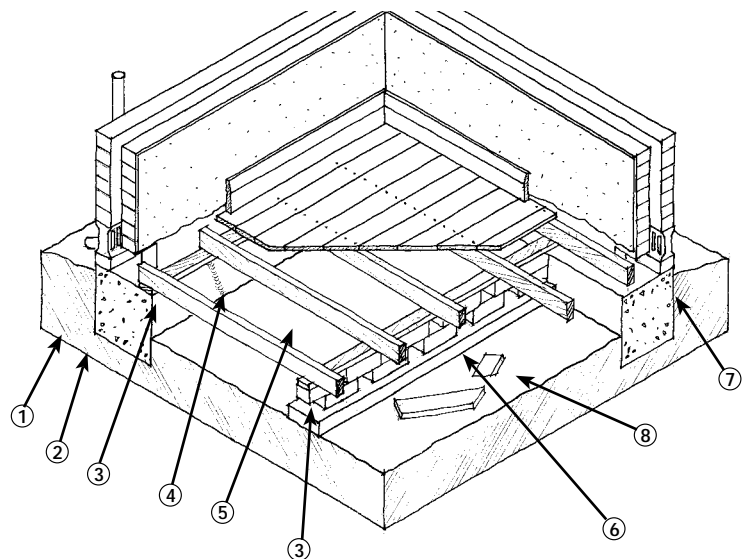
Potential Subfloor problems

1. Dampness in subfloor area from downpipes or leaking plumbing
2. Water ponding near wall, or entering through subfloor vents due to raised paving or ground levels
3. Absence of ant caps or damp proof membrane between timber floor plates and masonry dwarf walls
4. Termite tunnels giving access to timbers
5. Insufficient clearance between soil level and floor joists
6. Damaged or unstable dwarf walls
7. No damp proof course in external walls, or damp proof course damaged or bridged by repointing
8. Termites attracted by scraps of timber left on ground

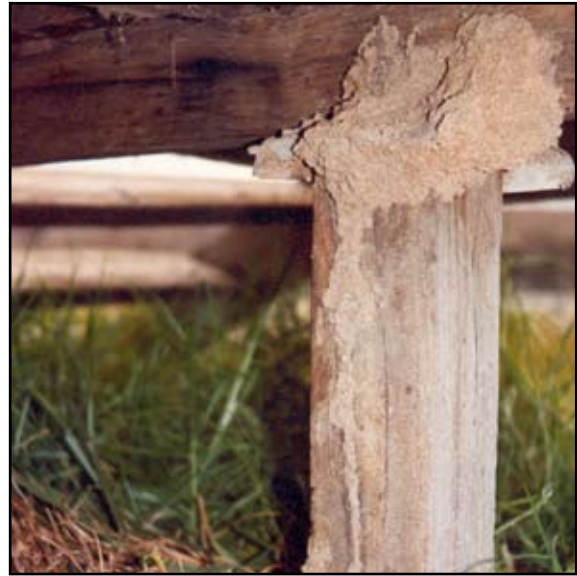
Termite attack on a stump

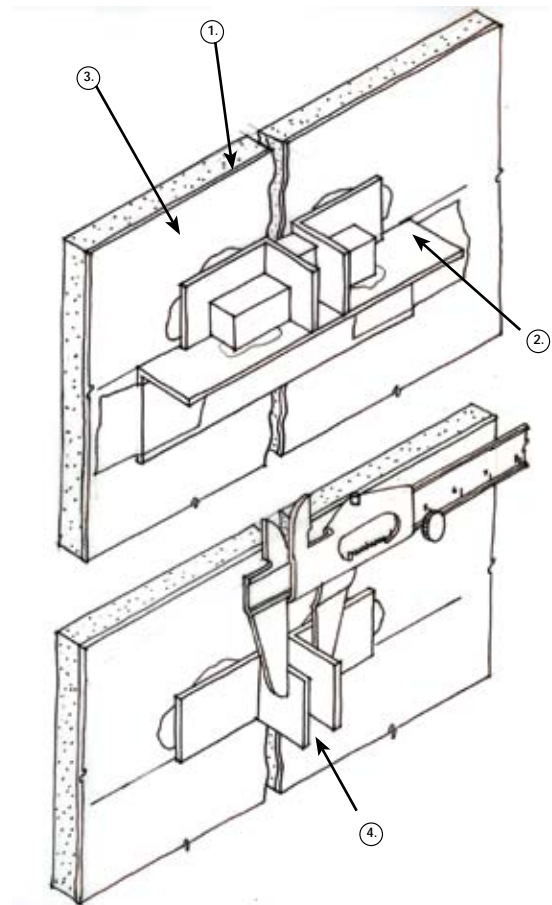
Tell-tale device

1. Crack tell-tale ex. – aluminium angle 20x30x2
2. Aluminium angle jig to hold tell-tales in place while epoxy glue sets.
3. Epoxy glue taped to wall surface
4. Tell-tales in place with jig removed – use vernier caliper to measure movement

A more complete method involves the construction of a 'tell tale' as illustrated. This monitoring should be carried out for at least twelve months, and preferably two years, in order to obtain an
